Hunters Point Naval Shipyard BCT Meeting

Parcel B (Excluding IR Sites 7 & 18) Remedial Action Update

December 6, 2012

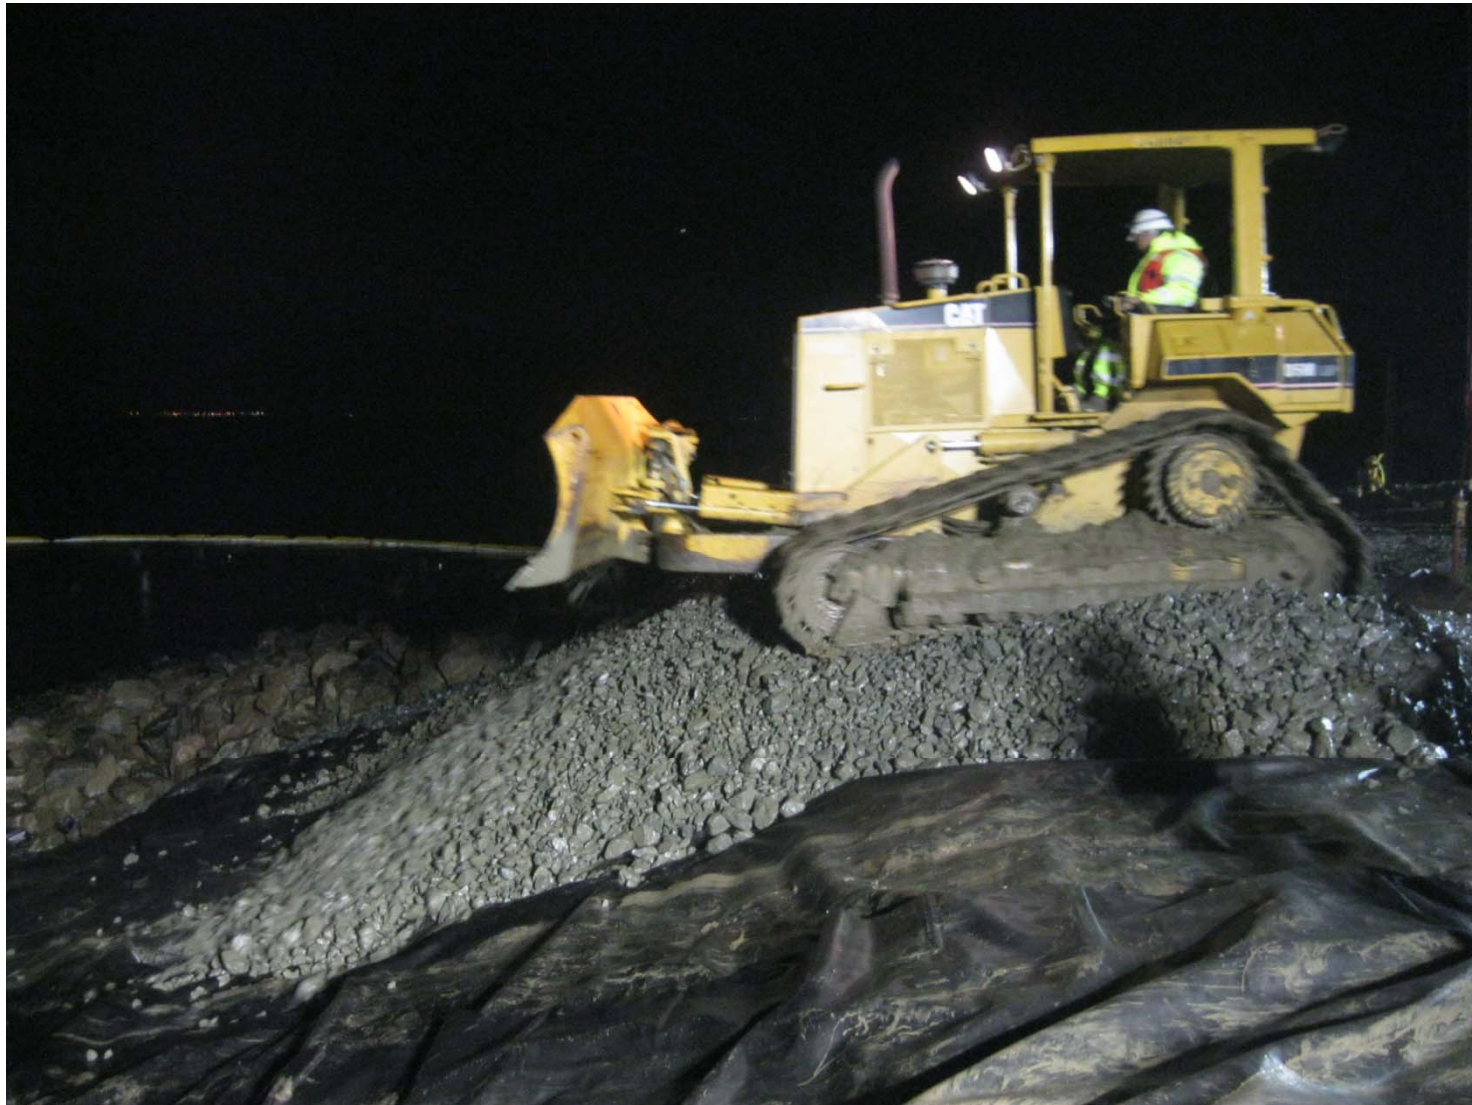
RA Photos Filter Rock Placement with Low Ground Pressure Bulldozer

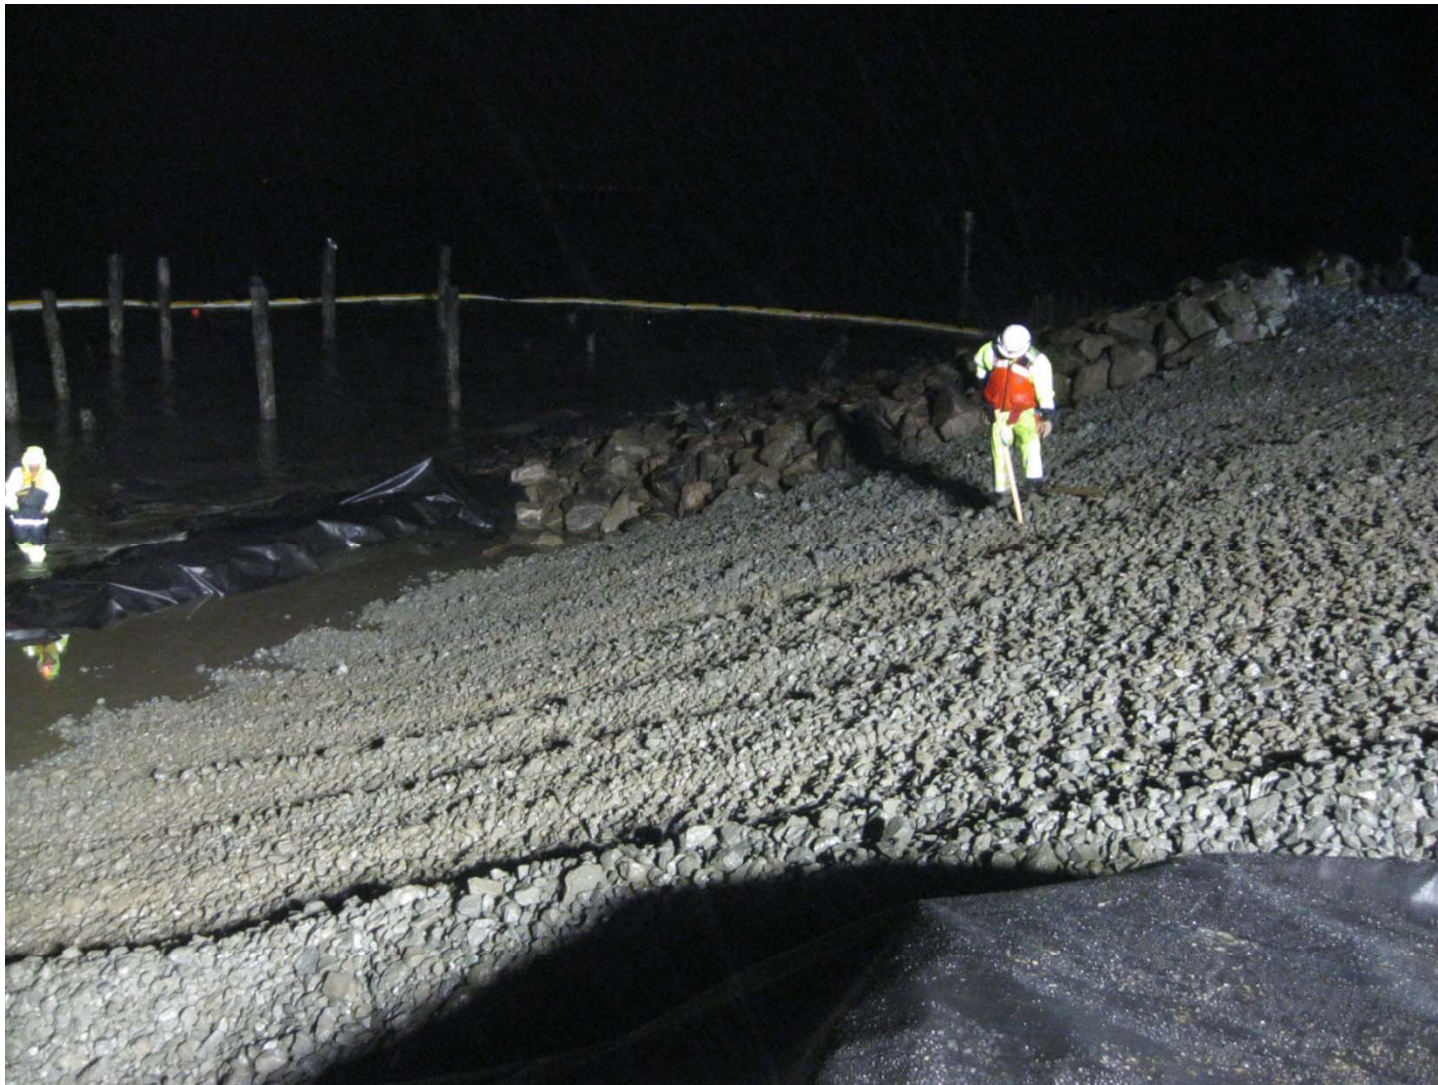
RA Photos Grade Checking Filter Rock Thickness

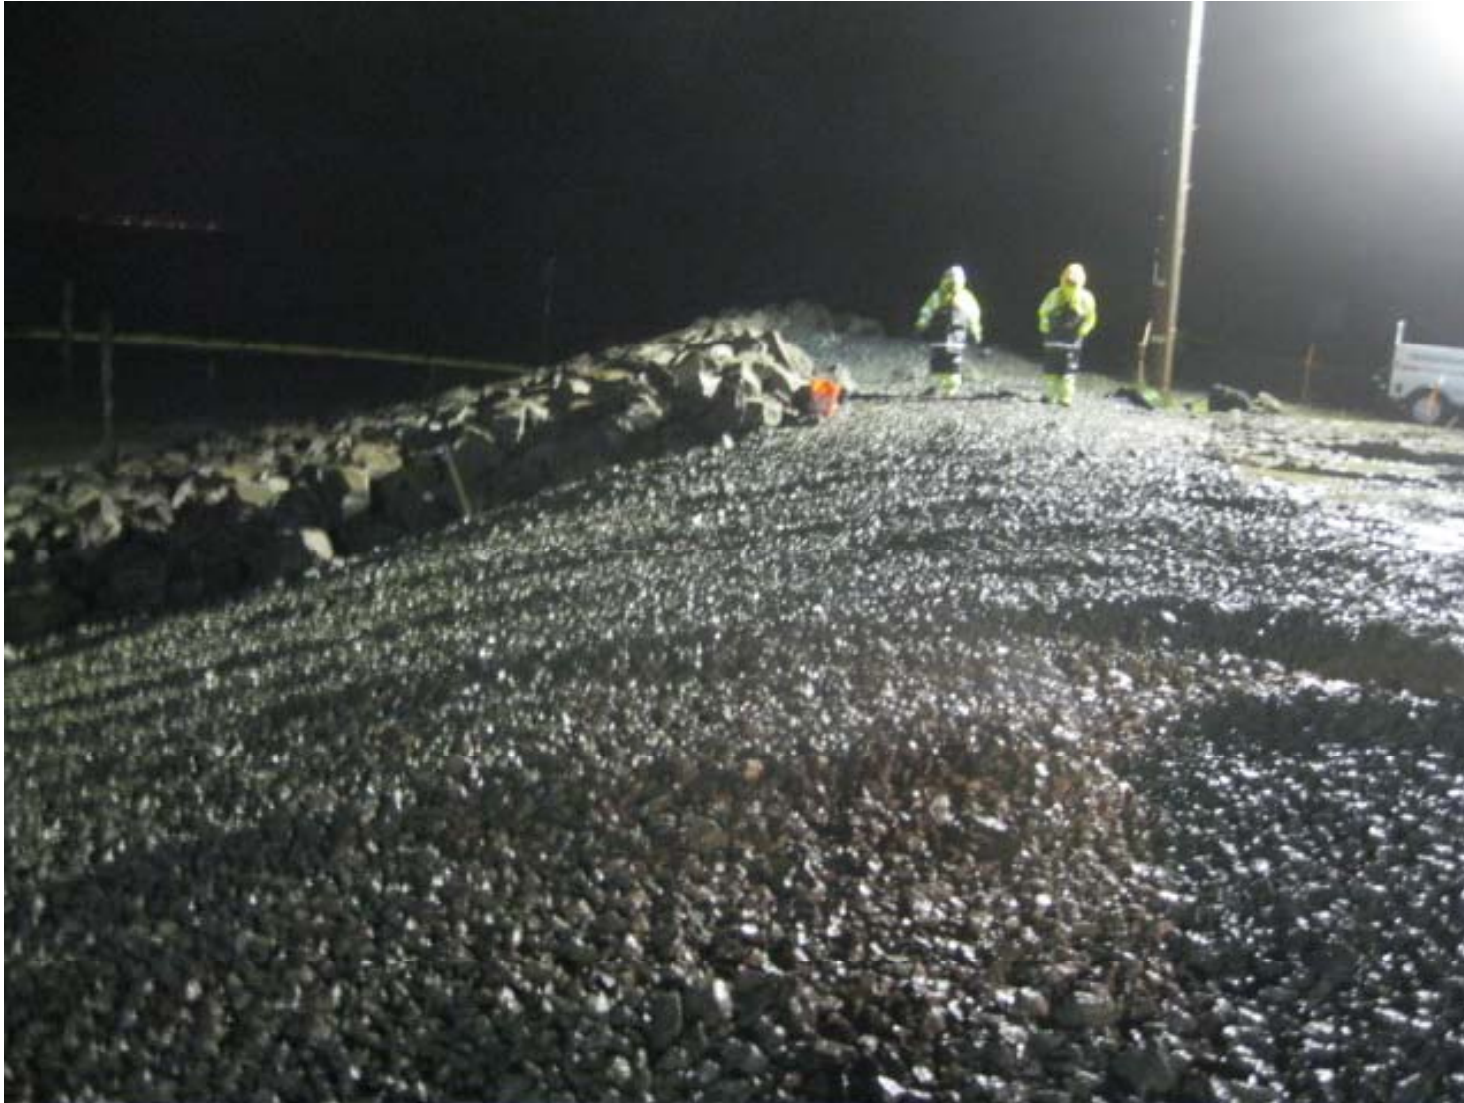
RA Photos Filter Rock Placement Complete

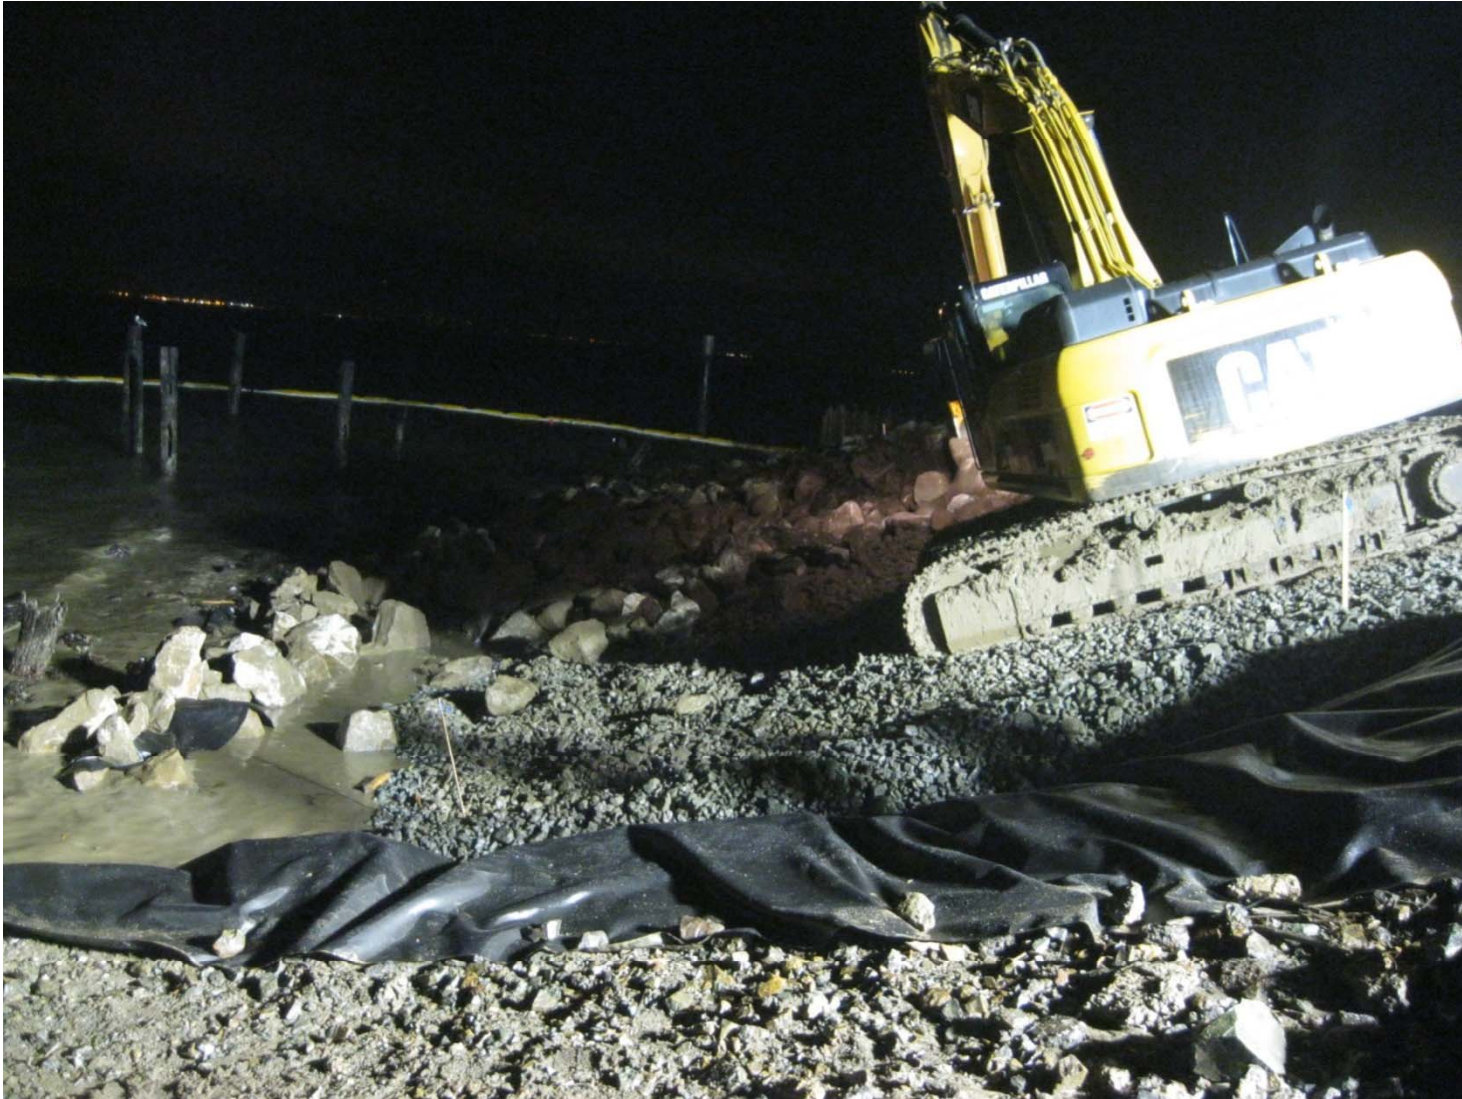
RA Photos Rip Rap Placement with Excavator

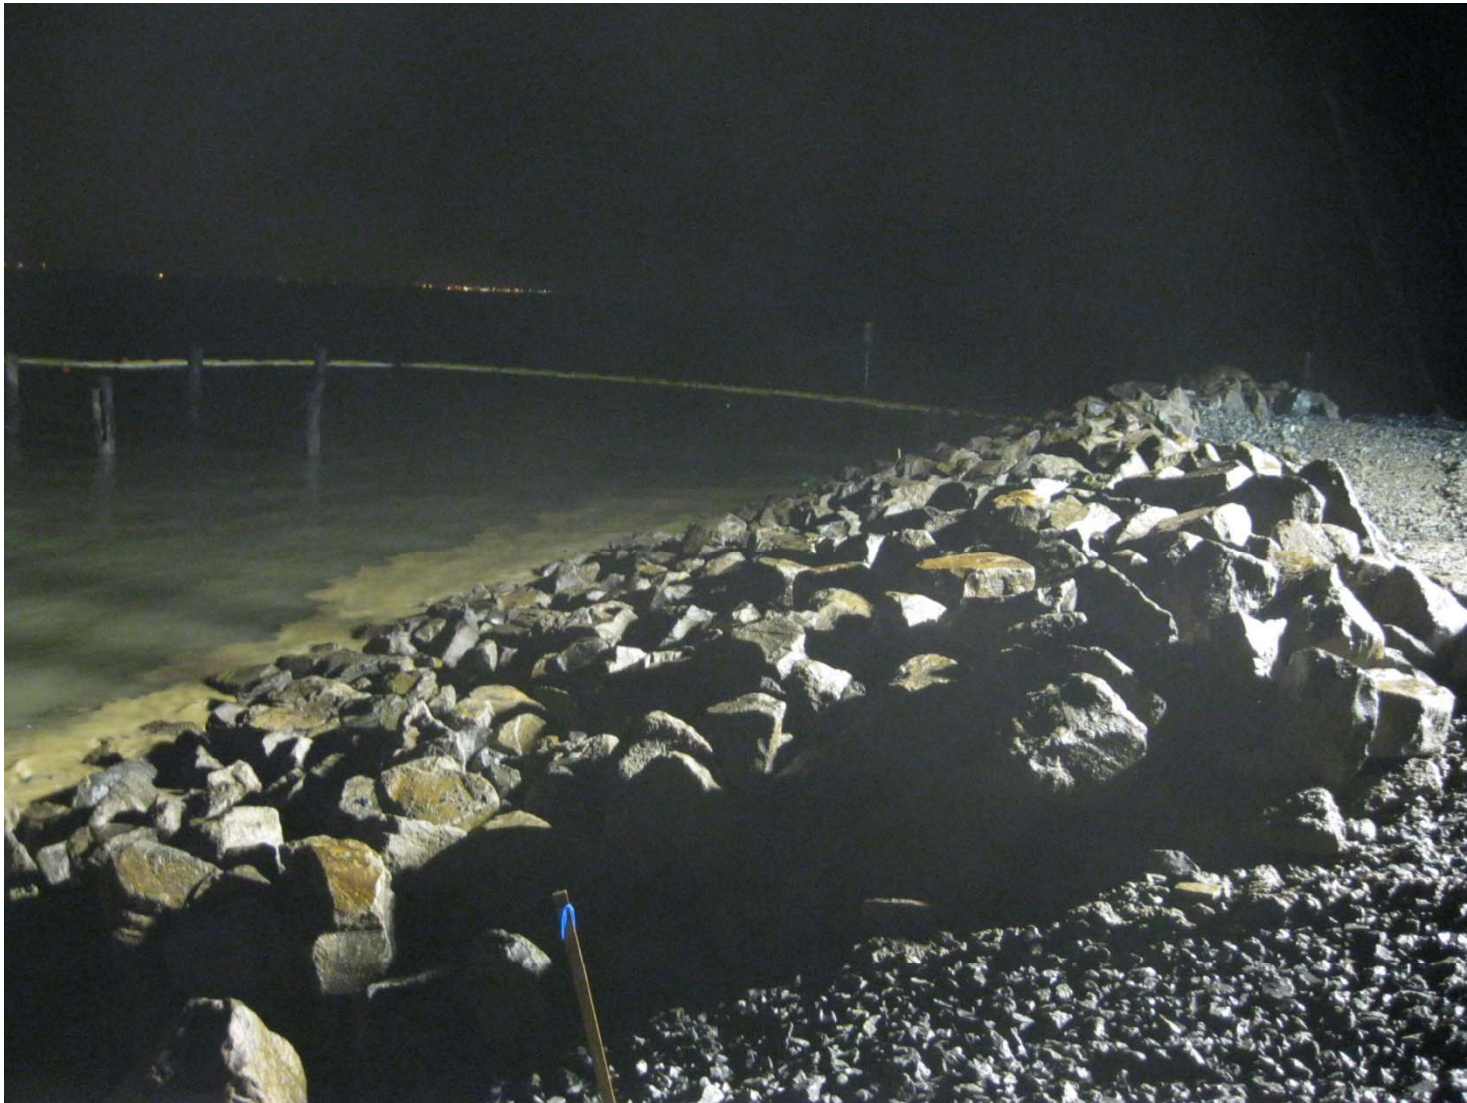
RA Photos Completed Revetment Section
